# Manhole Inspection Summary

Manhole # S39C\_\_034MH

Insp Date: **1/10/08 10:46 AM**

**Location** Address: **215 st matthew st**

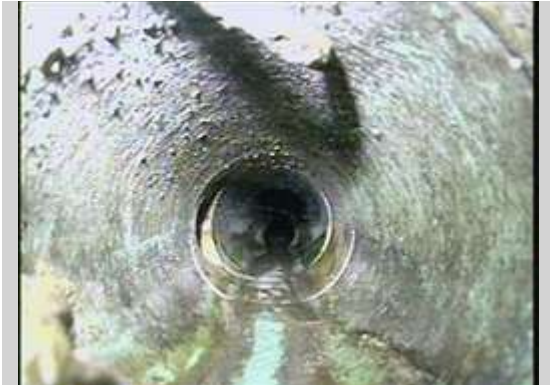
12 O'Clock Outflow

6 in. Circular Gravity Sewer  
Pipe Out @ 12 O'Clock

Pipe Height: 0 (in.) Direct

Pipe Material: PVC ☐ Pipe Lined

Infiltration: None Pipe Seal Cond: Unknown
